**ST MARY THE VIRGIN, LOWGATE
KINGSTON UPON HULL
ARCHAEOLOGICAL WATCHING BRIEF**

Faculty Reference: 2020-046705

JB Archaeology Ltd.

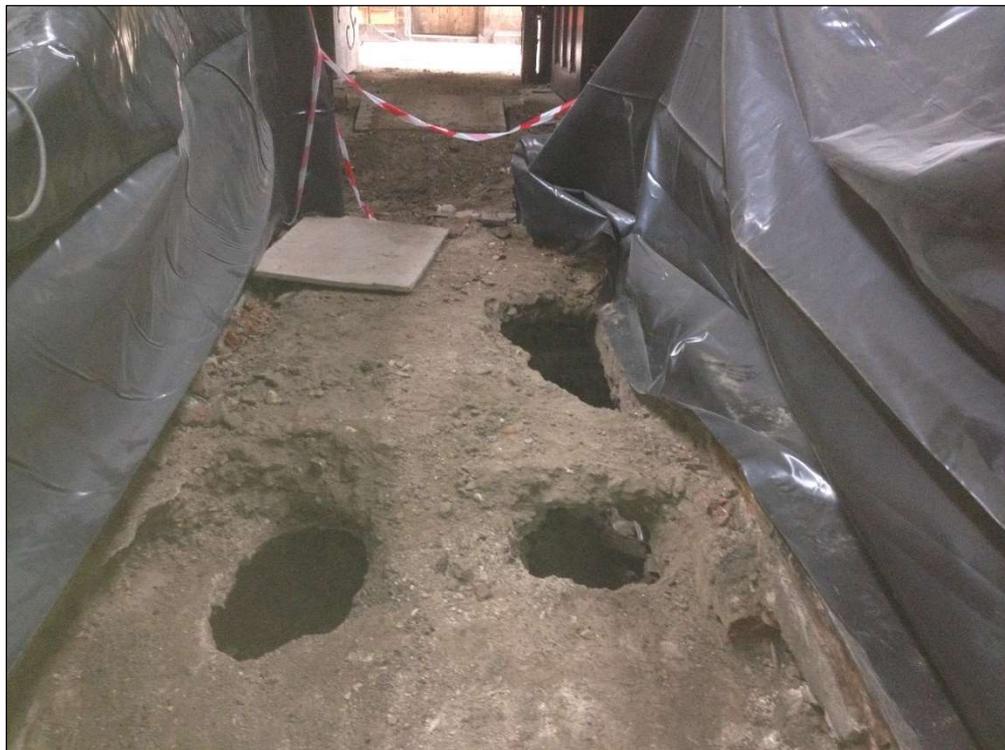
Plate 3. Voids under nave aisle, looking west

- 5.7 During the course of the removal of the 1860s floor a series of voids and ‘soft spots’ appeared in the underlying limecrete layer (Plate 3). On investigation the voids were found to be the remains of the brick built burial vaults. By the end of the stripping out a total of eight brick-built vaults had been identified with four of them being partially investigated (Figures 3&4, Plates 4&5).

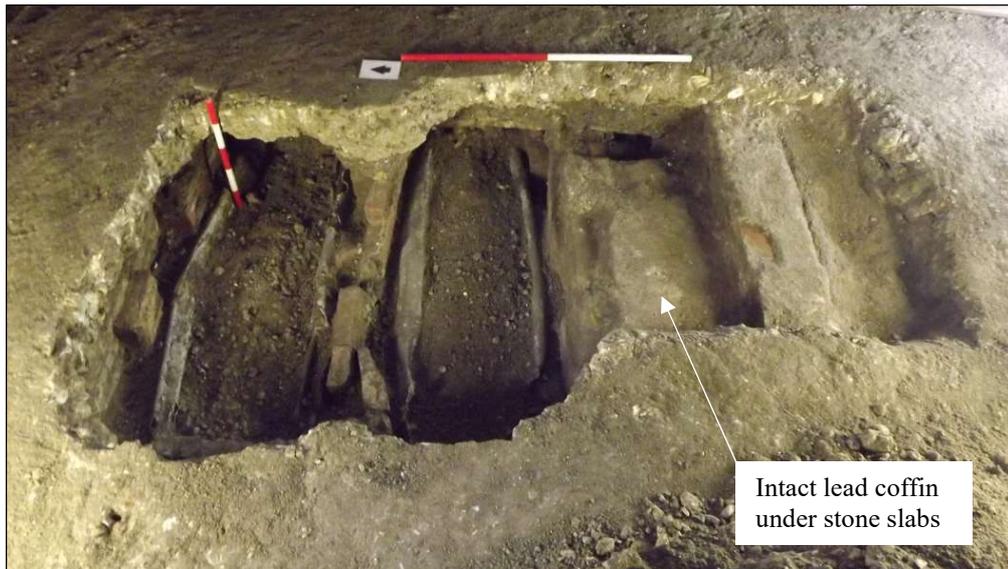
Plate 4. Brick vault [21], looking east, scales 0.5&1m

- 5.12 Of the brick vaults exposed, five of them could be seen to contain lead coffins: three in [21] and one each in [25&26]. Of these the most southerly coffin in [21] was intact and still largely covered by a row of stone slabs placed on top of the brick walls (Plate 4). The remaining exposed coffins had all been opened by having the lids cut out around the edges and then pulled off. This could be seen in the two exposed coffins in the vault at the eastern end of the inner south aisle (Plate 8). Here the lead can be clearly seen to be bent upwards at the head end of [18] and along the right-hand side of [19]. In addition to the obviously opened coffins all of the other voids did not appear to contain coffins and were simply partially filled with loose backfilled material.

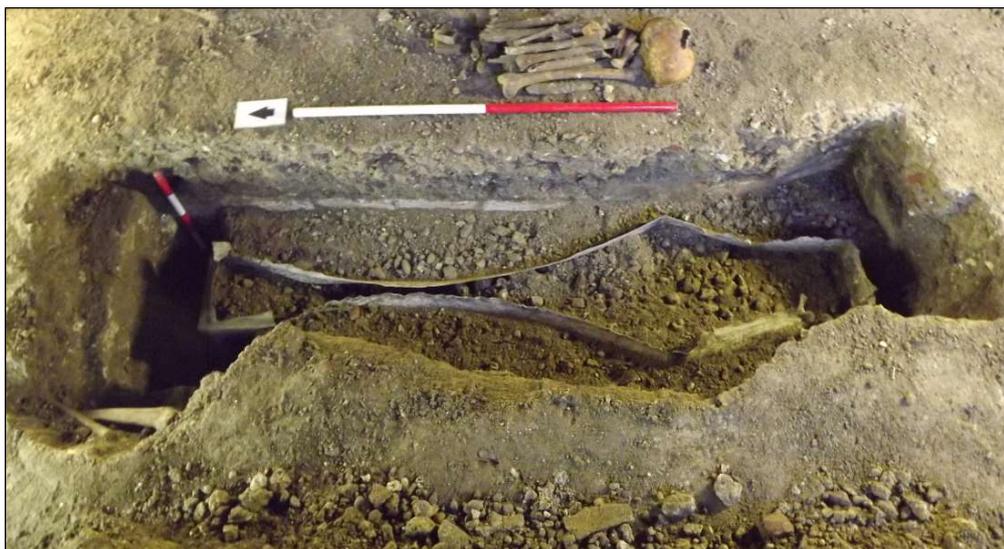
- 5.8 The exposed portions of the brick vaults all appeared to have been built with late 17th/18th century brick and were generally 2.10m long and 0.8m wide. The only vault (context [27]) investigated to its full depth was found to have 0.48m of brick work built up from a brick floor (at 2.84mOD) which had been covered by a layer of limecrete of varying thickness during the 1860s restoration works.

Plate 5. Brick vault [27], looking south (N arrow is incorrect), scales 0.5&1m

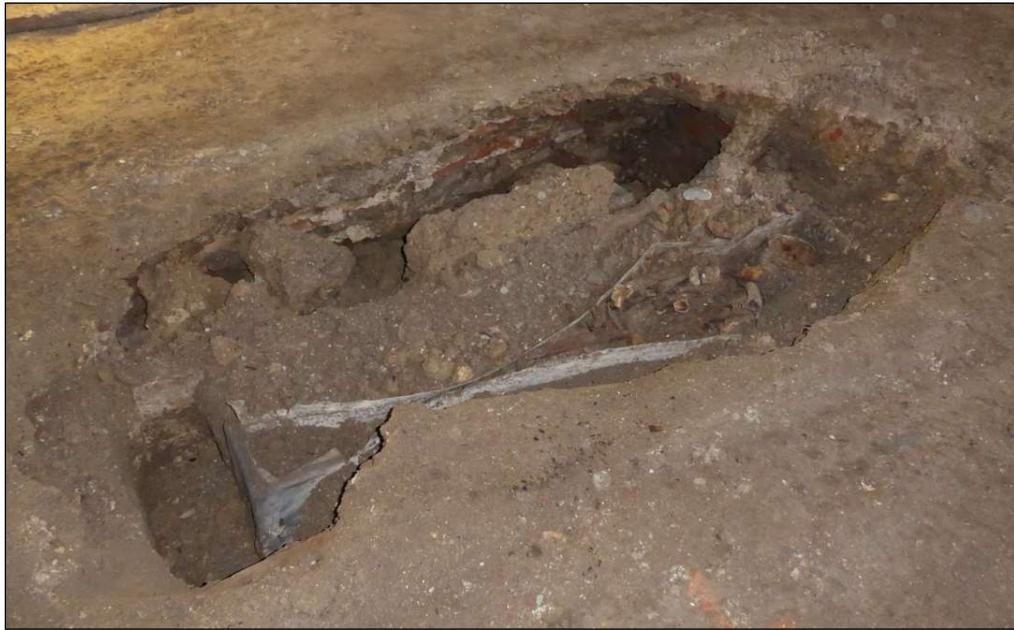
- 5.11 During the load testing for the new floor part of the 1860s floor over vault [25/26] was deliberately collapsed. This exposed more of the vault [26] which could be seen to run a further 600mm to the south. The newly exposed southern wall could be seen to be brick built, but very poorly finished and in addition appeared to have been either corbel built to form a barrel-vaulted roof or it has been pushed over/partially collapsed to the north (Plate 6). The resulting space exposed in [26] by the removal of the floor was reported as probably not being wide enough to contain a coffin. This would seem more likely to suggest that there is a degree of collapse than deliberate construction; though barrel-vaulting should not be ruled out as this type of construction is seen elsewhere in the church: at the north eastern corner for the cellar under the vestry. If this was barrel-vaulting the restoration work of the 1860s appears to have truncated the top of the corbelling, which may have been a contributory factor in the collapse of parts of the 1860s floor.

Plate 6. Vault [28] after floor collapse, looking south-west (D Sherriff)

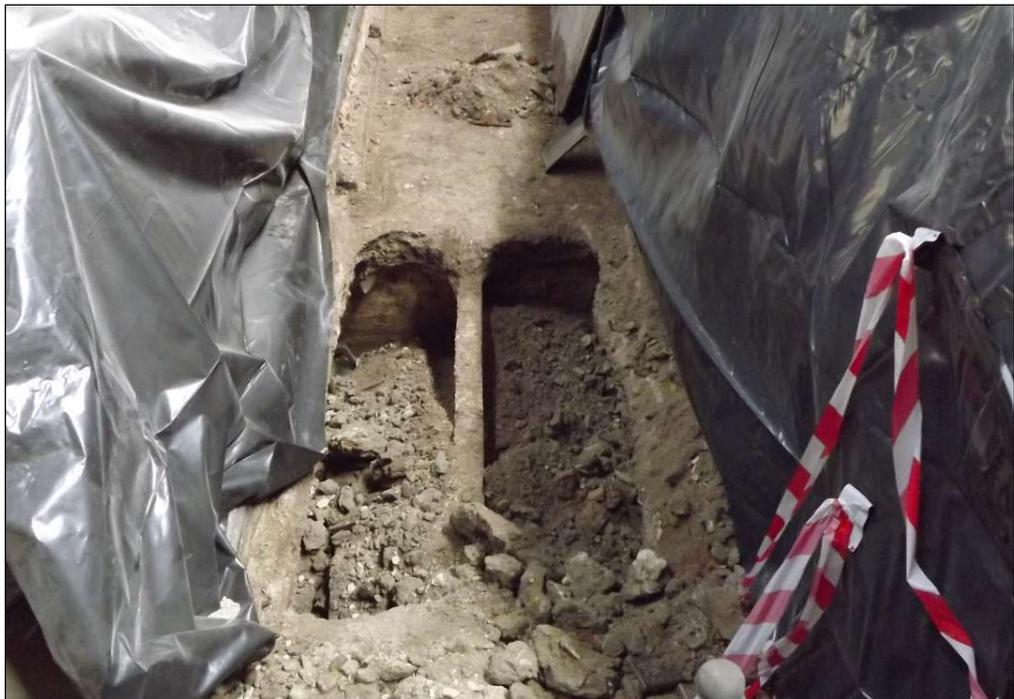
- 5.9 Due to the large space of the void in [29] and [30] (Plate 6) it was possible to see that at least these two vaults were deeper – to c.2.55mOD. This could be seen to suggest that they may have originally have had coffins stacked two high.

Plate 7. Vaults [29&30] as uncovered, looking east

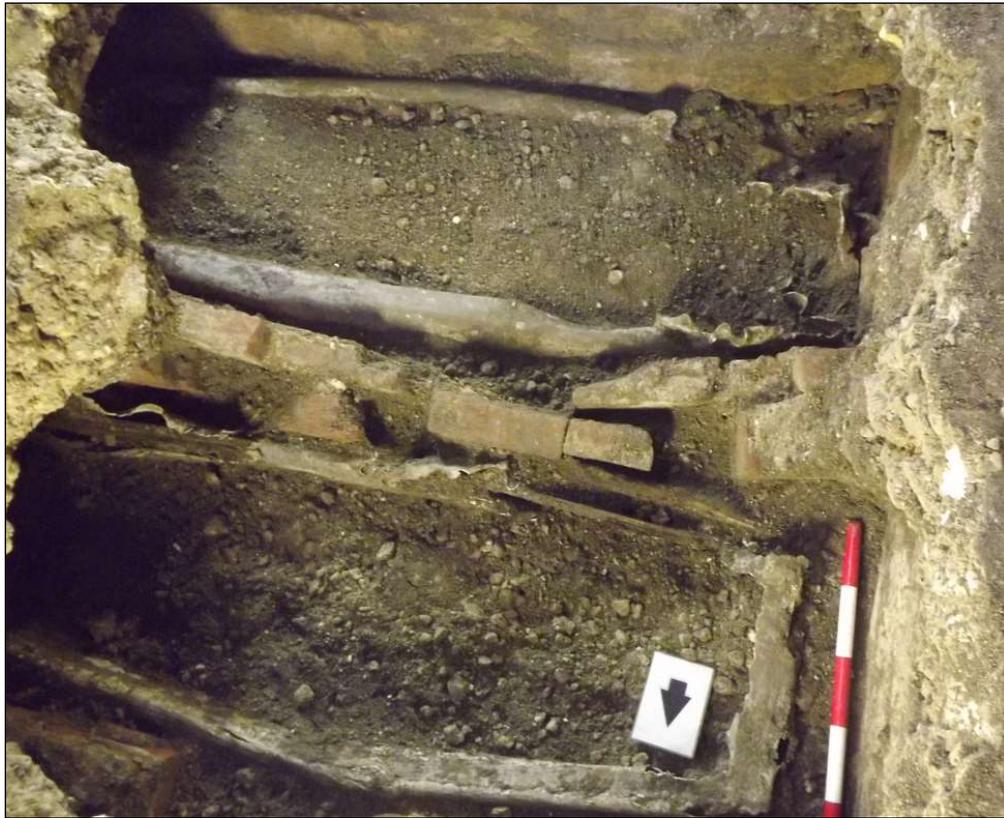
Plate 8. Opened coffins in [21], looking down, scale 0.5m

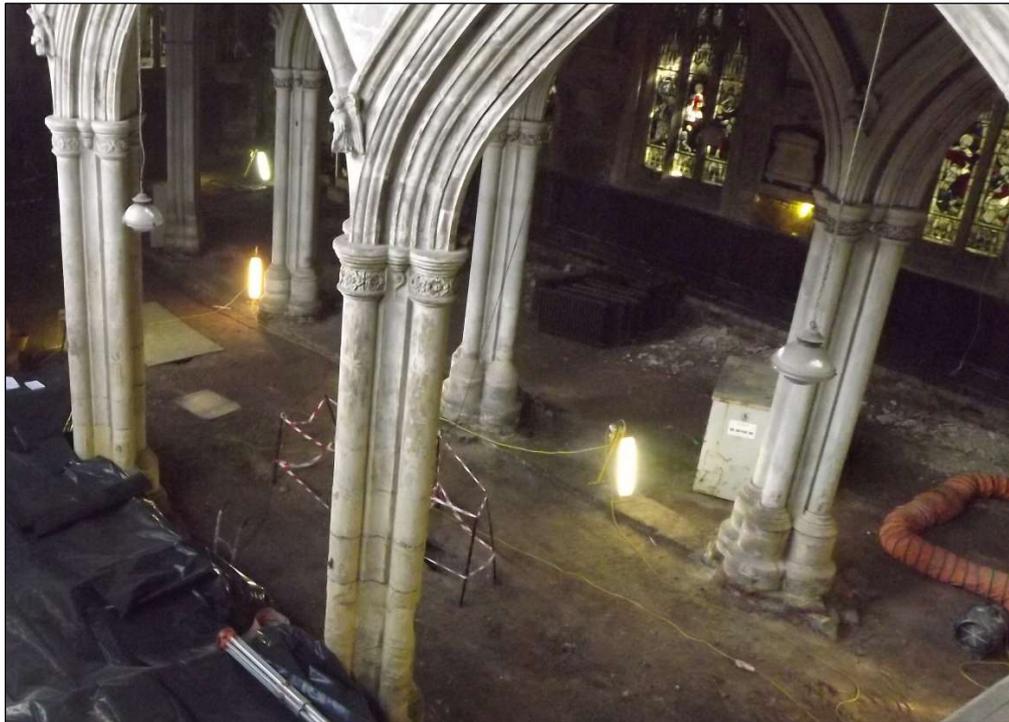
- 5.19 Probably the most significant discovery of the watching brief was the remains of a number of walls which once formed part of the earlier phases of the church (Figure 3). The most substantial surviving wall was located to the south of chancel and ran east-west (Plates 9&10). This wall would have originally been the south wall of the building before it was taken down in the 1860s restoration when the church was enlarged by the addition of a second south aisle. The wall could be seen to run continuously under the later internal columns but with a gap at either end so that it did not join with the eastern and western walls of the church.

Plate 9. Earlier wall running under 1860s columns, looking south-east

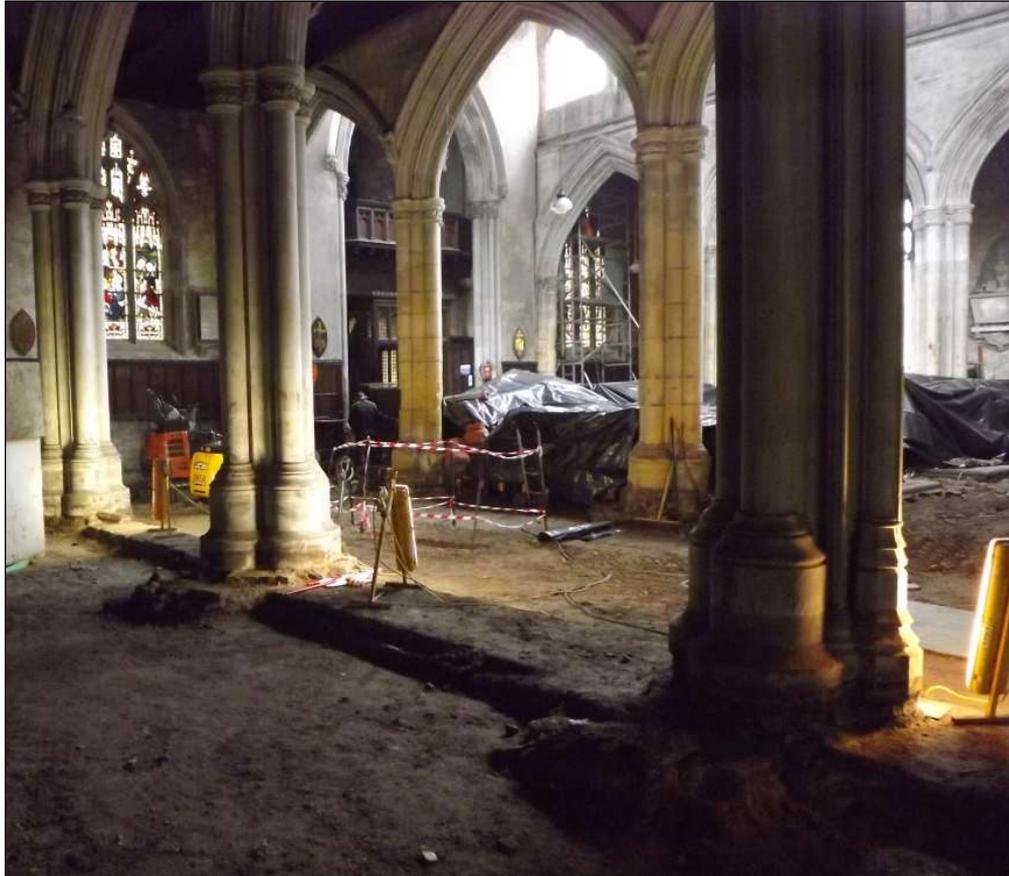
Plate 10. Earlier wall used to support 1860s columns, looking north-west

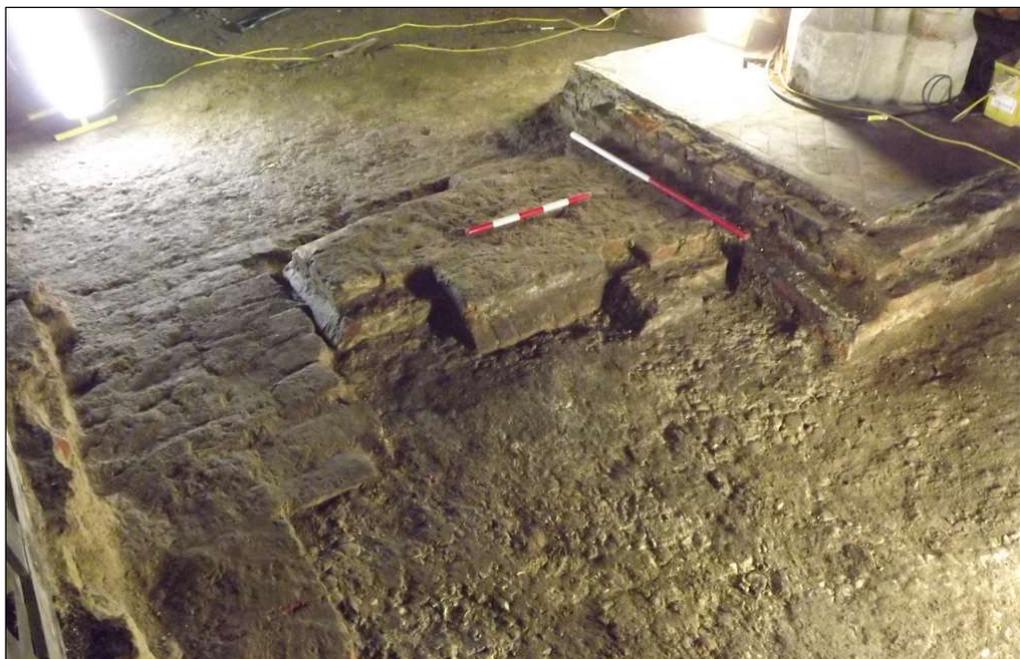
- 5.20 At the eastern end of the wall it could be seen to end in a stepped buttress built using moulded bricks, known as ‘moulded specials’, (S Tibbles, *pers comm*) to give a distinct chamfer to the stepped course (Plate 11, Figure 6). The shape of this buttress is noticeably different to those seen along the length of the rest of the wall (Plate 12) and may relate to when the southern aisle was known to be shorter – as depicted on the Cotton Manuscript held at the British Library (Figure 7).

Plate 11. Eastern end of earlier wall, looking south-east, scales 0.5&1m

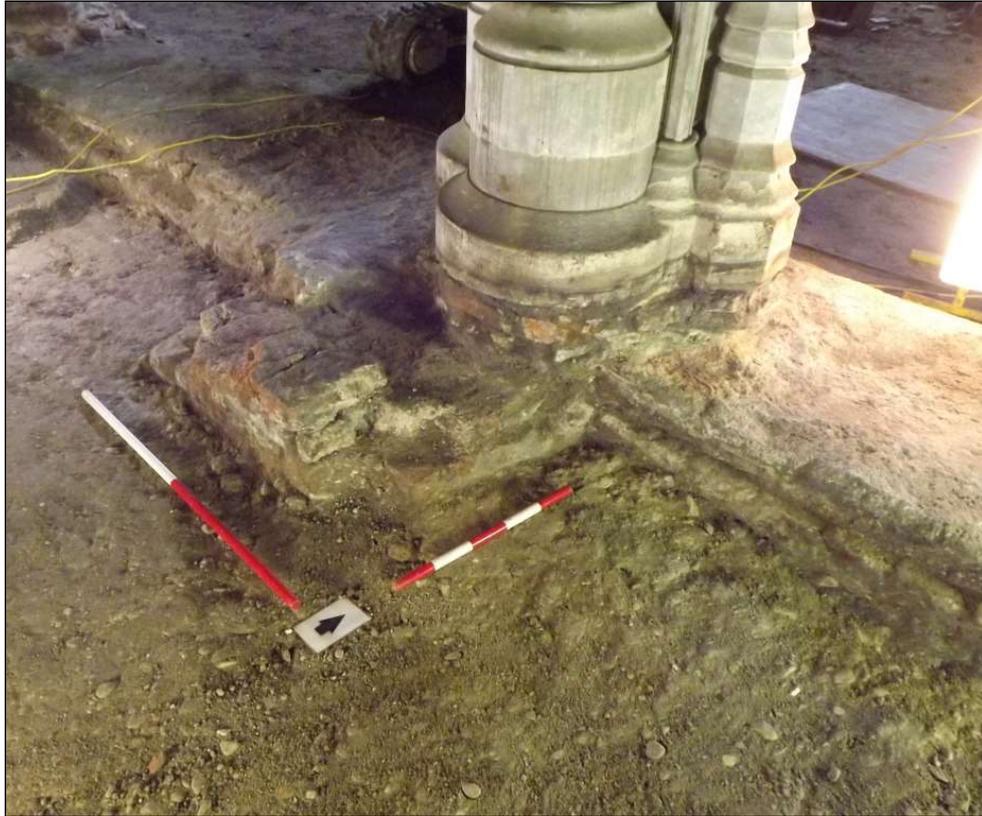
Plate 12. Second buttress from eastern end, looking north-west, scales 0.5&1m

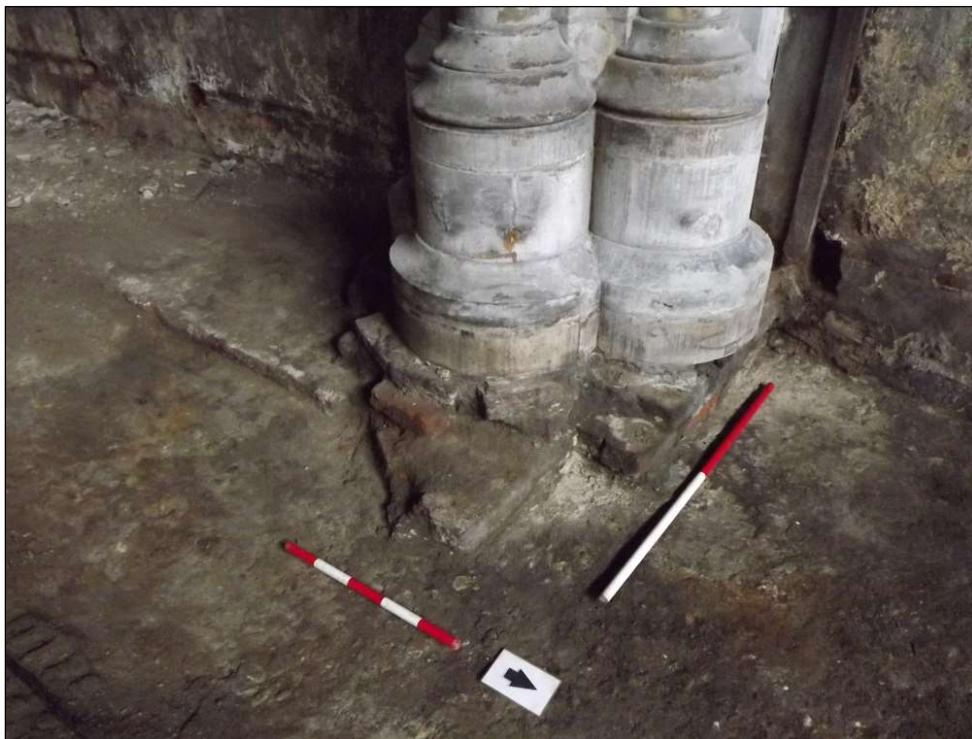
Plate 13. Western end of earlier wall, showing reveal for doorway, looking south-west, scales 0.5&1m

of a large opening. This is almost undoubtedly a large doorway with the angled reveals visible on the southern side of both jambs (Plate 13). On the westernmost side the angle of the reveal can be seen to join to the remains of a further substantial wall running to the east which was probably the boundary wall for the graveyard.

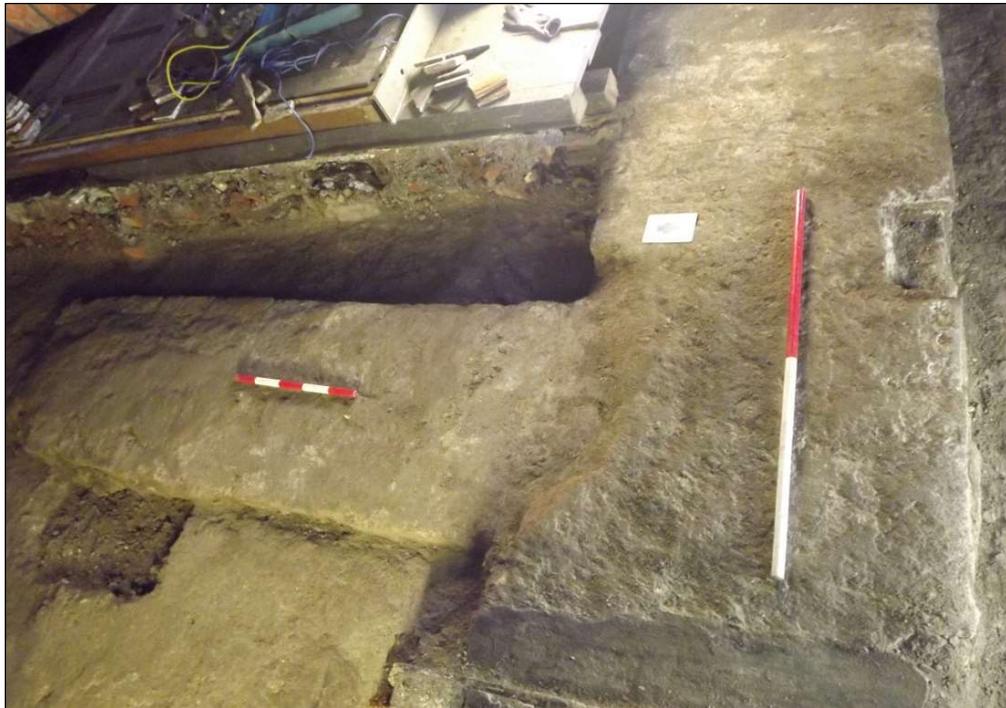
- 5.22 A further substantial wall was recorded at the eastern end of the substantial east-west wall running at right-angles to it to the south (Figure 3, Plate 14). It could be seen to have been cut into the main east-west wall at a later date. This probably represents the remains of an earlier vestry which is shown on the 1853 Ordnance Survey mapping (Figure 8). It is uncertain as to when it was originally built but a structure is shown in this location in images dating to 1780 and 1790 (Figures 10&11). Interestingly these engravings show what appears to be a tall chimney on the south-eastern corner which may explain the large potential void identified during the ground penetrating radar survey (see Appendix IV).

Plate 14. Later N-S wall cut into earlier E-W wall, looking west, scales 0.5&1m

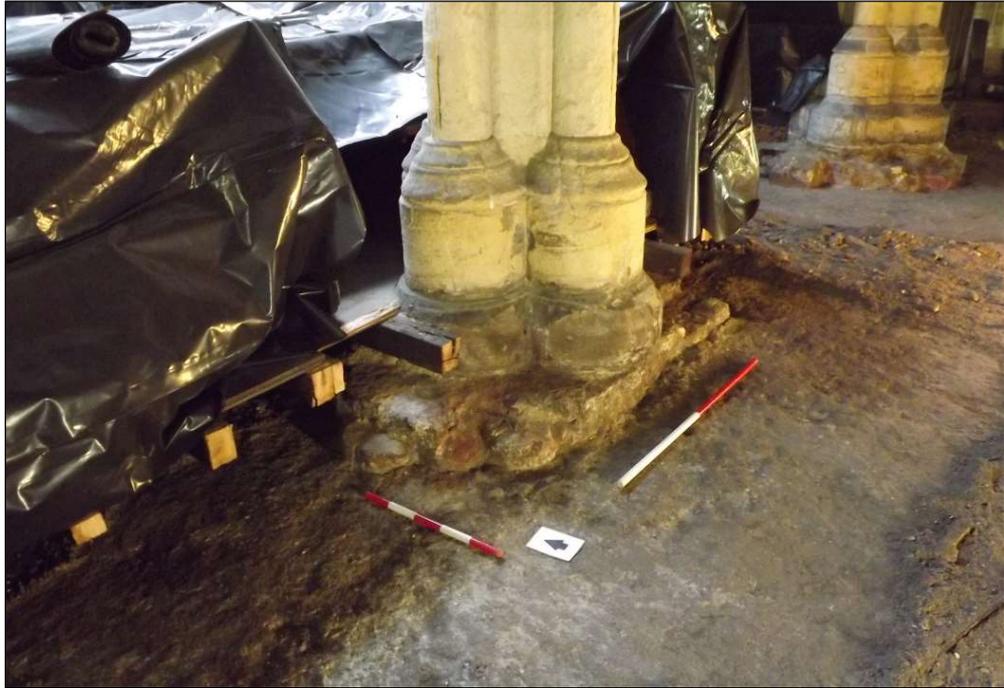
- 5.23 The final traces of the earlier form of the church could be seen at the bases of some of the columns in the nave. The most obvious remains could be seen on the south side of the nave (Plate 15; Figures 3&6). Here, under the later stone columns, where the remains of elaborate column bases formed from the same style of moulded bricks seen in the main east-west wall (Plates 15&16). In the case of one of the bases a small part of the earlier brick floor still remained *in situ* (Plate 17). These brick bases can be seen to be earlier than the stone columns above them as the centre lines of the stone columns and brick bases do not align and there is a noticeable discontinuity in the construction between the bases and the brickwork supporting the columns. There is also a similar misalignment in the column bases on either side of the rood screen. Here the column bases are formed from a combination of brick and stone suggesting a further different phase of construction (Plate 18).

Plate 15. Earlier brick column base, looking north-east, scales 0.5&1m

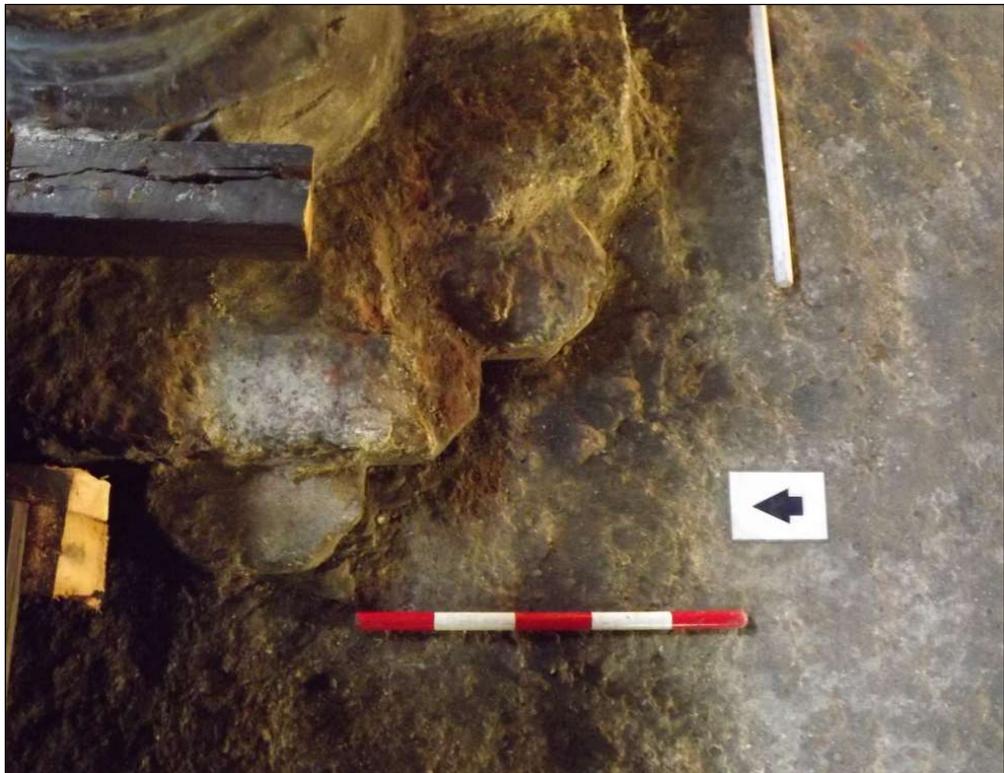
Plate 16. Earlier brick column base, looking down, scales 0.5&1m

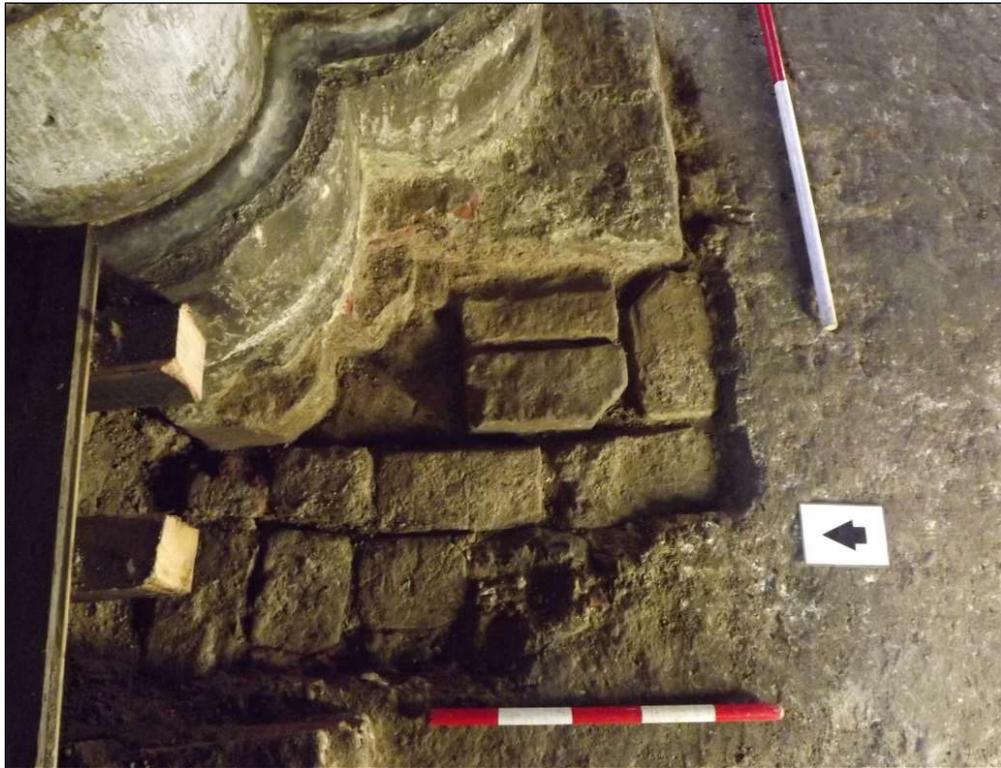
Plate 17. Earlier brick column base, with surviving brick floor, looking down, scales 0.5&1m

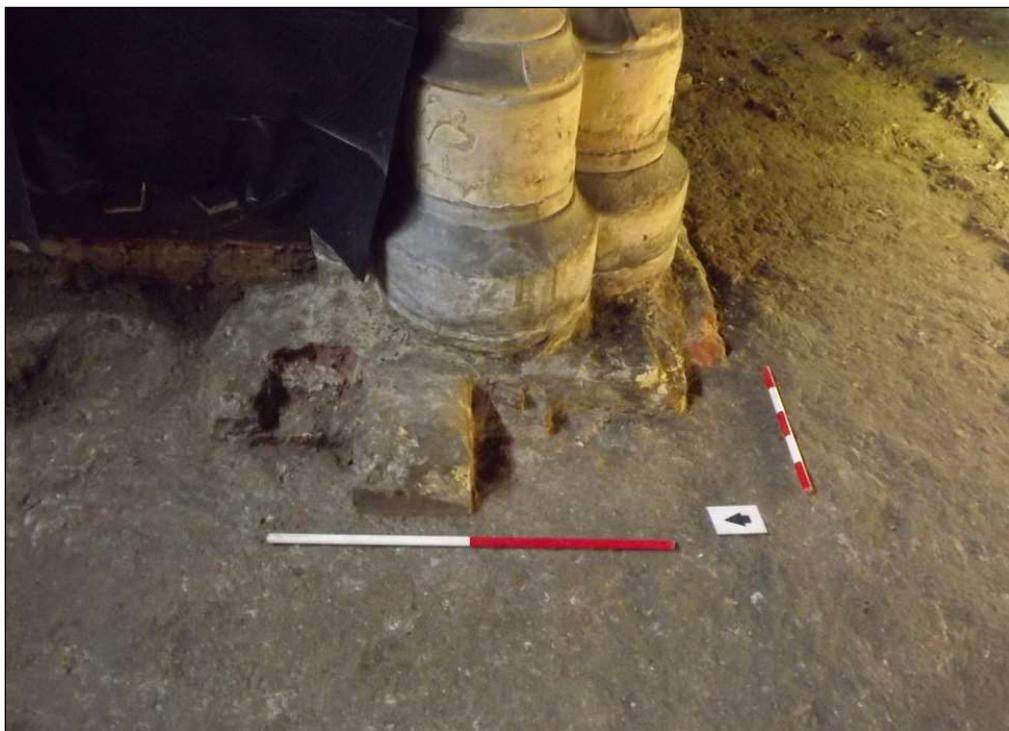
Plate 18. Earlier brick and stone column base, looking east, scales 0.5&1m
